Their curving roofs make the school buildings blend perfectly into the environment.

Project Data

System Build-up:
"Rockery Type Plants" with Floradrain®
FD 40-E on an Inverted Roof

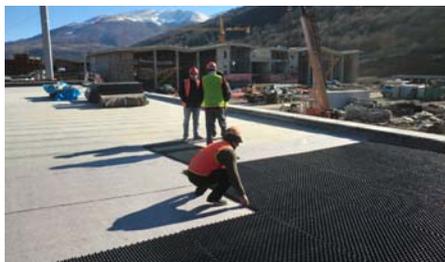
The drainage elements were laid butt jointed on all roof surfaces.

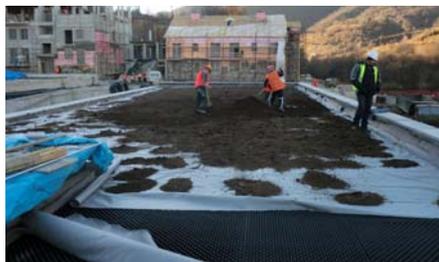
The substrate which was mixed on-site previously was applied all over the system filter.

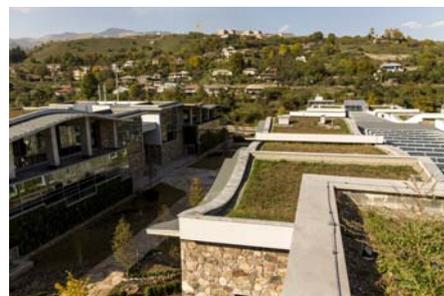
In order to preserve and increase biodiversity the roofs are mowed only twice a year.
